4 Lip Shower Tray TEST REPORT

MTL Report No.	J58153.1	Order No.	CASH SALE	Date Tested	12/11/2020
Client Name	Henry Brooks & Co Ltd.			Attention	Brent Coutts
Test Method	A shower tray was placed directly on a concrete floor and repeatedly loaded with 200 kgs approximately in the same position for 5000 cycles of loading and unloading. A rubber padding was placed directly under the loading feet at a specified position to replicate foot loading.				
Test Equipment	Riken 70 MPa pump Serial No. 22968 with AEP transducer and DFP pressure gauge w/ 5 tonne ram

Same Tray with a further 10000 cycles at 300KG weight

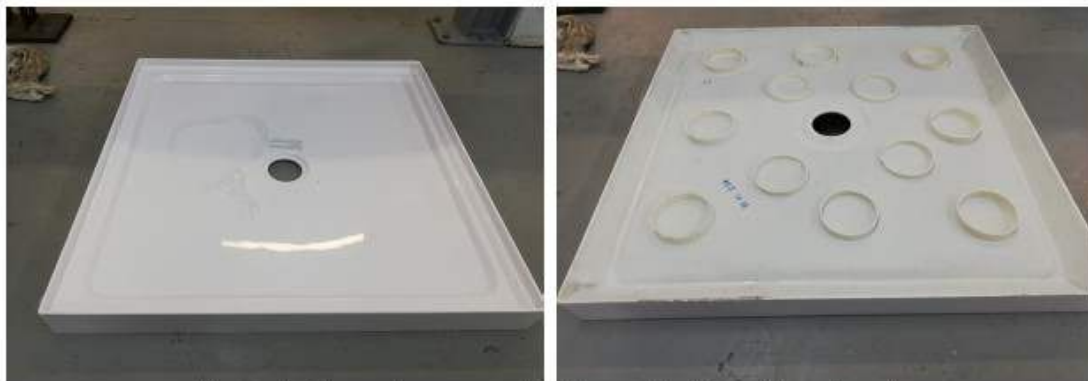
Figure 1: Shower tray as supplied (top and bottom of tray shown)

Main findings: After a total of 5000 load cycles, no defects were observed on both top and bottom surfaces of the shower tray tested.

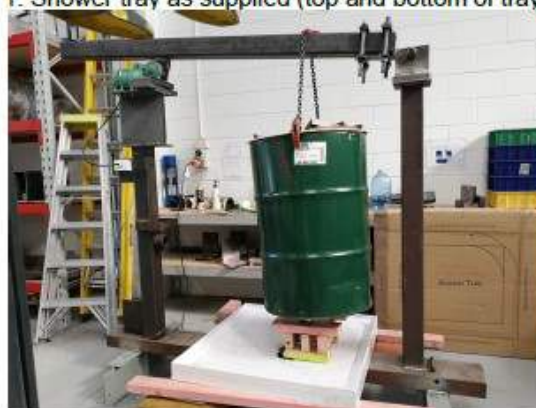
Figure 2: Testing conducted on cyclic loading frame

MTL Report No.	J58290.1	Order No.	CASH SALE	Date Tested	14/12/2020
Client Name	Henry Brooks & Co Ltd.			Attention	Brent Coutts
Test Method	A shower tray was placed directly on a steel beam and repeatedly loaded with 300 kgs approximately in the same position for 10,000 cycles of loading and unloading. A rubber padding was placed directly under the loading feet at a specified position to replicate foot loading.				
Test Equipment	Electric motor, cyclic loading frame, 300kg weights each verified using a Mass Balance (S/N: MTL-MECH-SC01)
