4 Lip Shower Tray TEST REPORT

MTL Report No.	J58153.1	Order No.	CASH SALE	Date Tested	12/11/2020
Client Name	Henry Brooks & Co Ltd.			Attention	Brent Coutts
Test Method	A shower tray was placed directly on a concrete floor and repeatedly loaded with 200 kgs approximately in the same position for 5000 cycles of loading and unloading. A rubber padding was placed directly under the loading feet at a specified position to replicate foot loading.				
Test Equipment	Riken 70 MPa pump Serial No. 22968 with AEP transducer and DFP pressure gauge w/ 5 tonne ram

MTL Report No.	J58290.1	Order No.	CASH SALE	Date Tested	14/12/2020
Client Name	Henry Brooks & Co Ltd.			Attention	Brent Coutts
Test Method	A shower tray was placed directly on a steel beam and repeatedly loaded with 300 kgs approximately in the same position for 10,000 cycles of loading and unloading. A rubber padding was placed directly under the loading feet at a specified position to replicate foot loading.				
Test Equipment	Electric motor, cyclic loading frame, 300kg weights each verified using a Mass Balance (S/N: MTL-MECH-SC01)

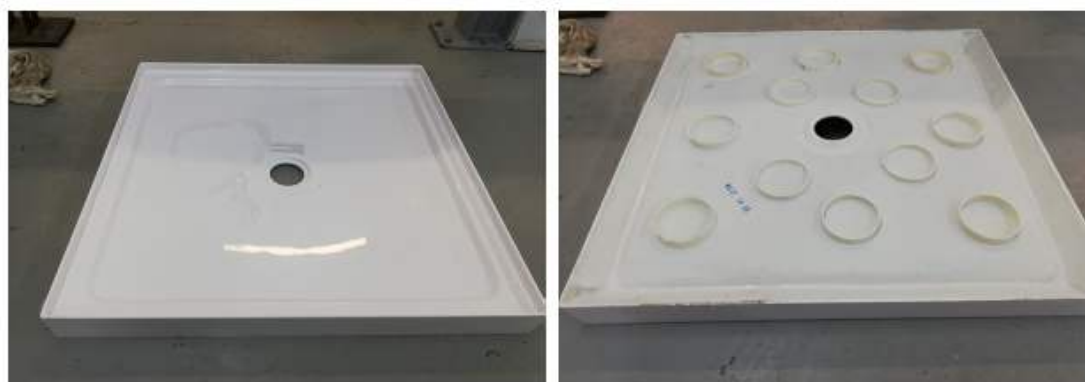
Figure 1: Shower tray as supplied (top and bottom of tray shown)

Main findings: After a total of 5000 load cycles, no defects were observed on both top and bottom surfaces of the shower tray tested.

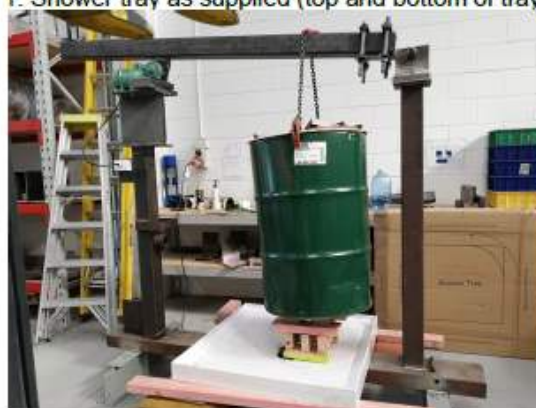
Figure 2: Testing conducted on cyclic loading frame

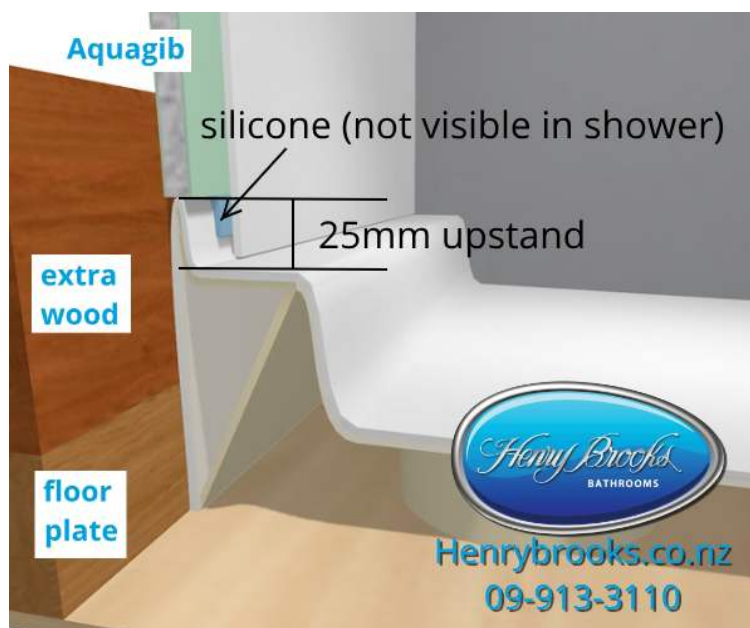
Center Waste

Upstands are between 25mm and 28mm high
